**LARCHMONT WATER COMPANY
DAM NO 2**

**WESTCHESTER COUNTY
NEW YORK**

INVENTORY NO 112

**PHASE I INSPECTION REPORT
NATIONAL DAM SAFETY PROGRAM**

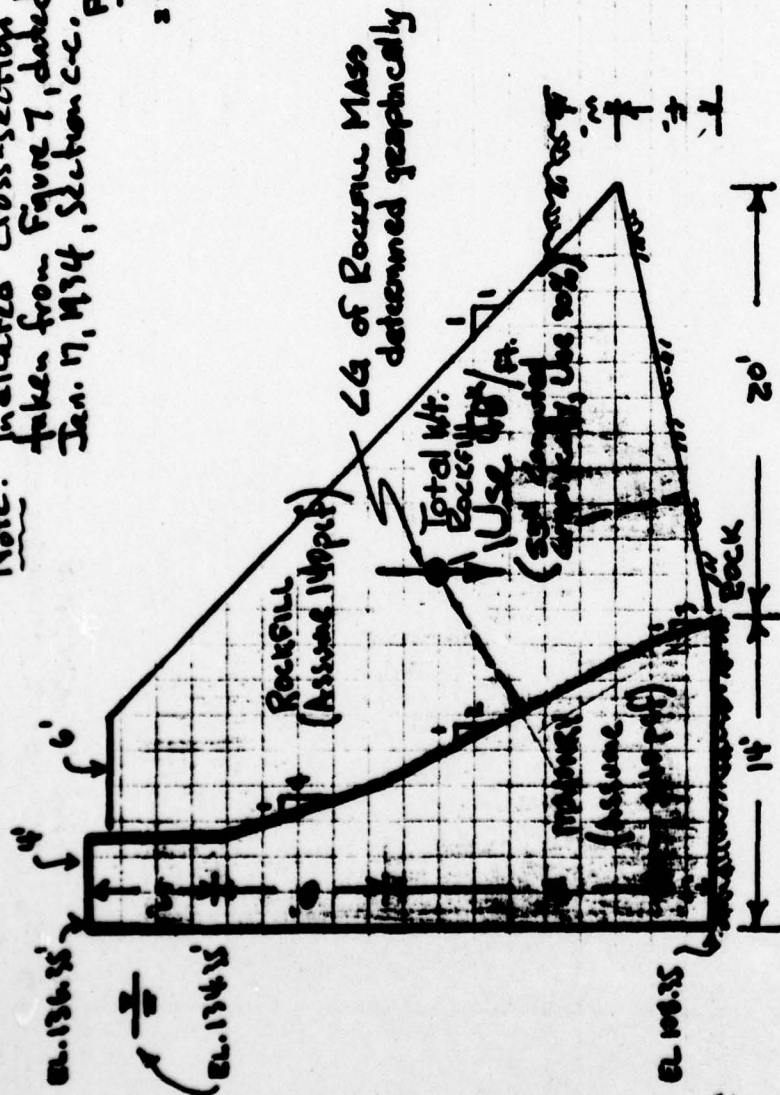
DAM CROSS-SECTION INDICATED FROM
COMPOSITE DESIGN DRAWINGS (ORIGINAL
DESIGN AND SUBSEQUENT ENLARGEMENT)

$$\text{FS} = \frac{104,000}{60,000} = 1.7 \pm$$

Note: Indicated cross-section taken from Figure 7, dated Jan. 17, 1934, Section C-C.

DAM CROSS-SECTION AND
LOADING CONDITIONS ASSUMED
FOR ANALYSIS TO EVALUATE
OVERTURNING ABOUT THE

- (1) Dam masonry and rockfill have a unit weight of 140 pcf.
- (2) Rockfill behind original masonry dam does not act as an integral part of the dam structure to resist overturning (conservative assumption) but does exert lateral force and friction on the back face of the masonry dam.
- (3) Ice force near reservoir surface is due to ice one-ft. thick subject to temp change of 10°F .

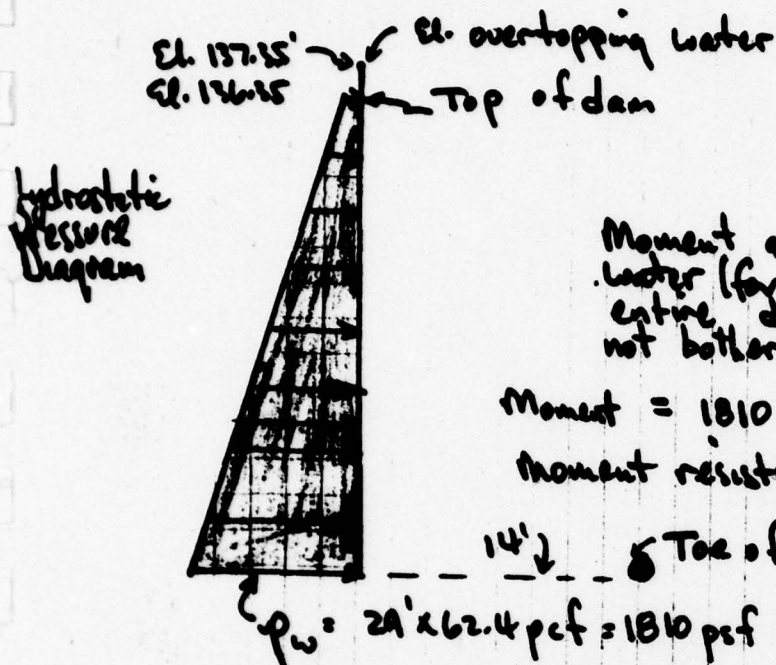
IV. Resistance to overturning When Reservoir Level Overtops Dam By One Foot

Moment about toe of dam due to water (for simplicity of calculation, use entire diagram up to Elev. 137.35, do not bother to subtract topmost one foot)

$$\text{Moment} = 1810 \text{ pcf} \times \frac{29'}{2} \times \frac{29'}{3} = 252,000 \text{ ft-lb/lin. ft.}$$
